**- INSPECTION REPORT
NATIONAL DAM SAFETY PROGRAM**

**HACKER DAM
MADISON COUNTY, MONTANA
MT - 1276**

January 1981

Subject: Hacker Dam (MT-1276) Field Inspection

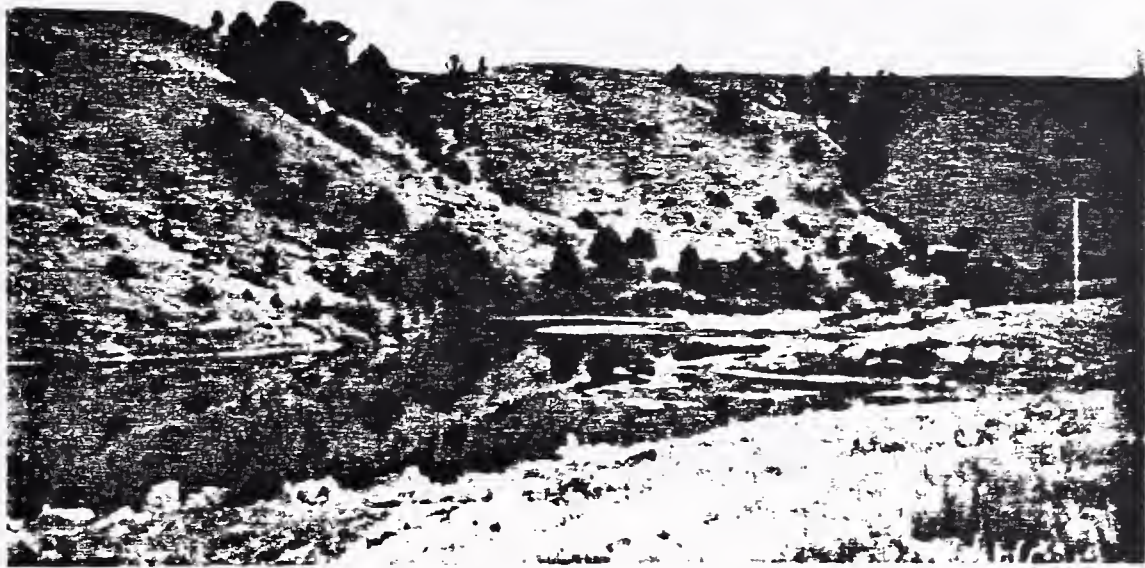
PHOTO 1
Reservoir Area

The dam has been constructed in a narrow valley, formed by down cutting of Moores Creek through the cobble and gravel terrace deposits. (Photo 1) Down-cutting proceeded until Precambrian bedrock was encountered at the left abutment (Photo 2 - background). The creek subsequently began to follow this bedrock contact; the valley then begins to fan and widen out just downstream from the dam. The dam abuts two different types of material. The left abutment is Precambrian gneiss, schists, and quartzite. These rocks are very decomposed and weathered. The rocks strike approximately parallel to the dam and dip downstream at about 70°. The quartzite beds form distinctive units that are approximately 6 inches to 2 feet thick and are interbedded throughout the exposure. The right abutment of the dam is a heterogeneous deposit of Pleistocene cobbles and coarse sand and gravel. (Plate 3)

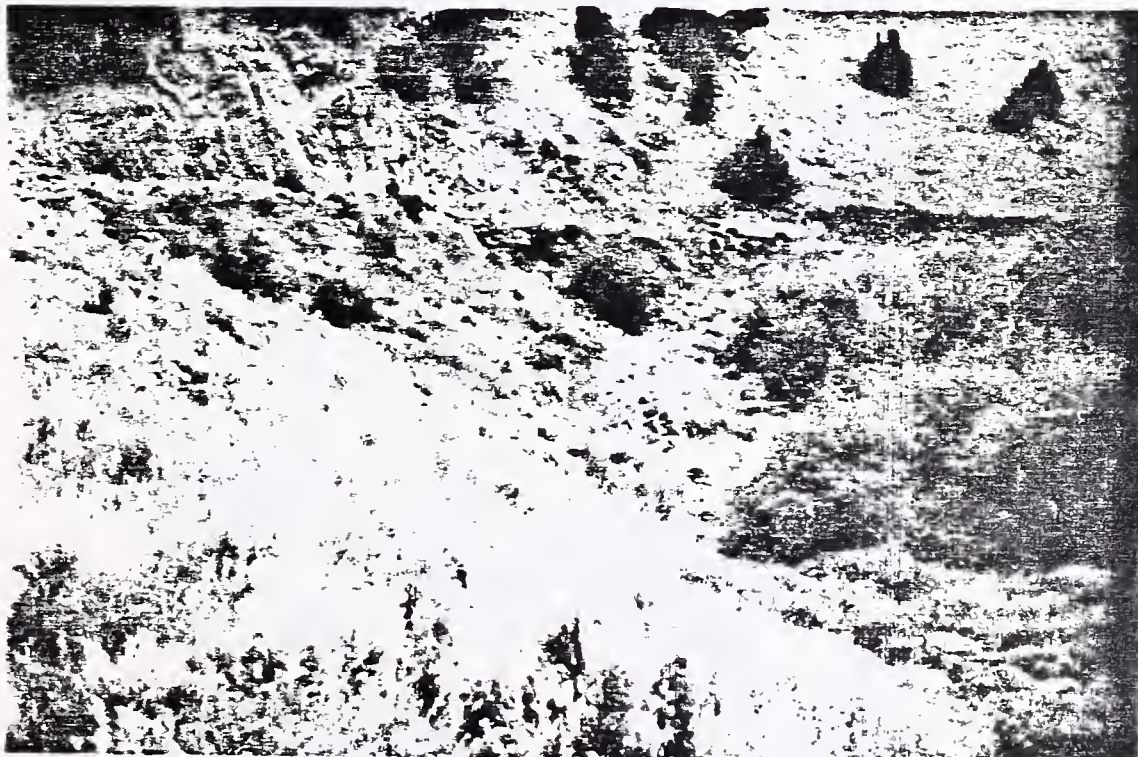
PHOTO 2
Downstream Face of Dam

The downstream slope had a heavy grass and sage brush cover except in the area of the above mentioned repair.(Photo 3) Minor evidence of animal traffic and rodent burrowing was observed. Seepage observed near the right abutment was traced in a northerly direction across the slope face approaching the area repaired in 1976. Some small seeps were noted in the area of the left abutment.

6. Continue to monitor localized seepage observed high on the embankment and at the abutment contact. Should seepage show signs of increasing with accompanying material movement at the embankment exit, take immediate steps to drawdown the reservoir. Conduct engineering studies to design modifications to correct observed conditions. These studies should be conducted by a geotechnical engineer experienced in earth dam design and construction. Modify the project as studies indicate.

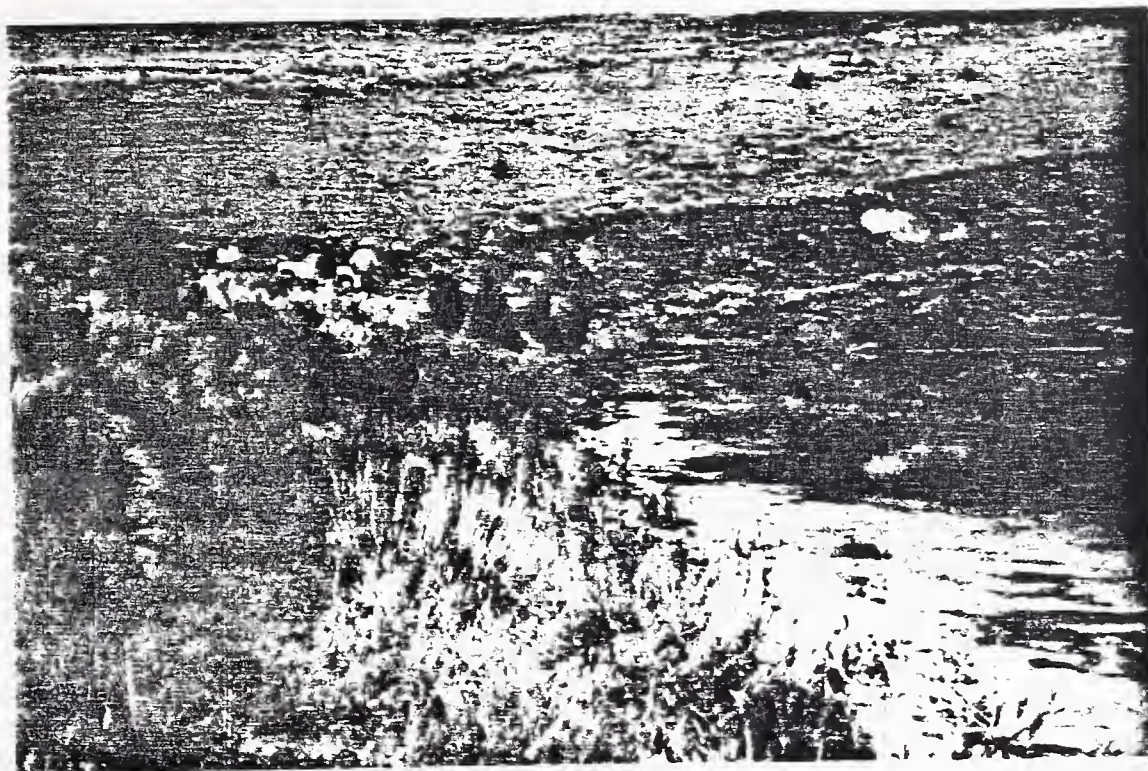
PHOTO 3
Upstream Face of Dam

The upstream slope was generally well vegetated with grasses and sagebrush. No other slope protection was apparent. (Photo 3) Wave erosion of minor consequence was noted.

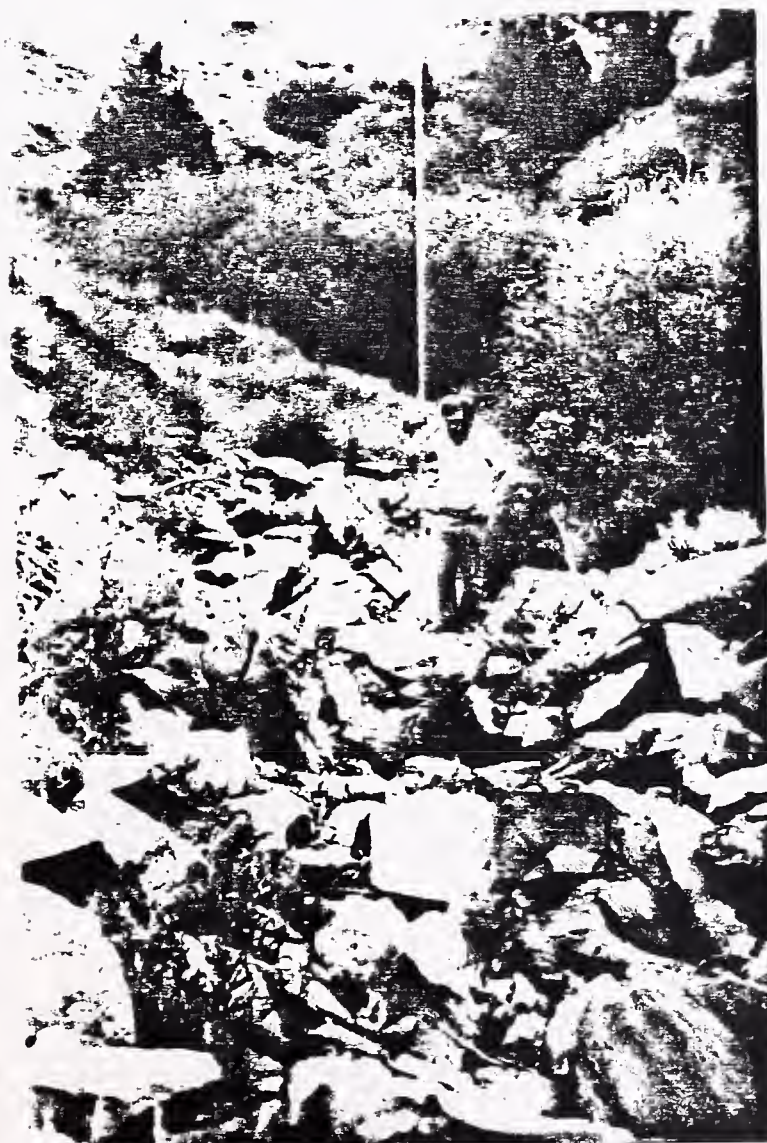
PHOTO 4
Emergency Spillway Looking Downstream

The areas around the principal spillway conduit and approaching the emergency spillway channel were covered with riprap, (Photo 4). The emergency spillway exit channel has apparently experienced erosion in the past. Large diameter rock has been placed in the exit channel bottom to prevent scour erosion that could be caused by frequent use of the emergency spillway. (Plate 4) The effectiveness of the loose rock riprap under high flow conditions would be questionable. (Photo 4)

5. Inspect the project during and after flood events to determine conditions that may effect the safety of the dam, with particular attention to erosion conditions in the emergency spillway exit channel and downstream embankment toe. Make immediate repairs as required.

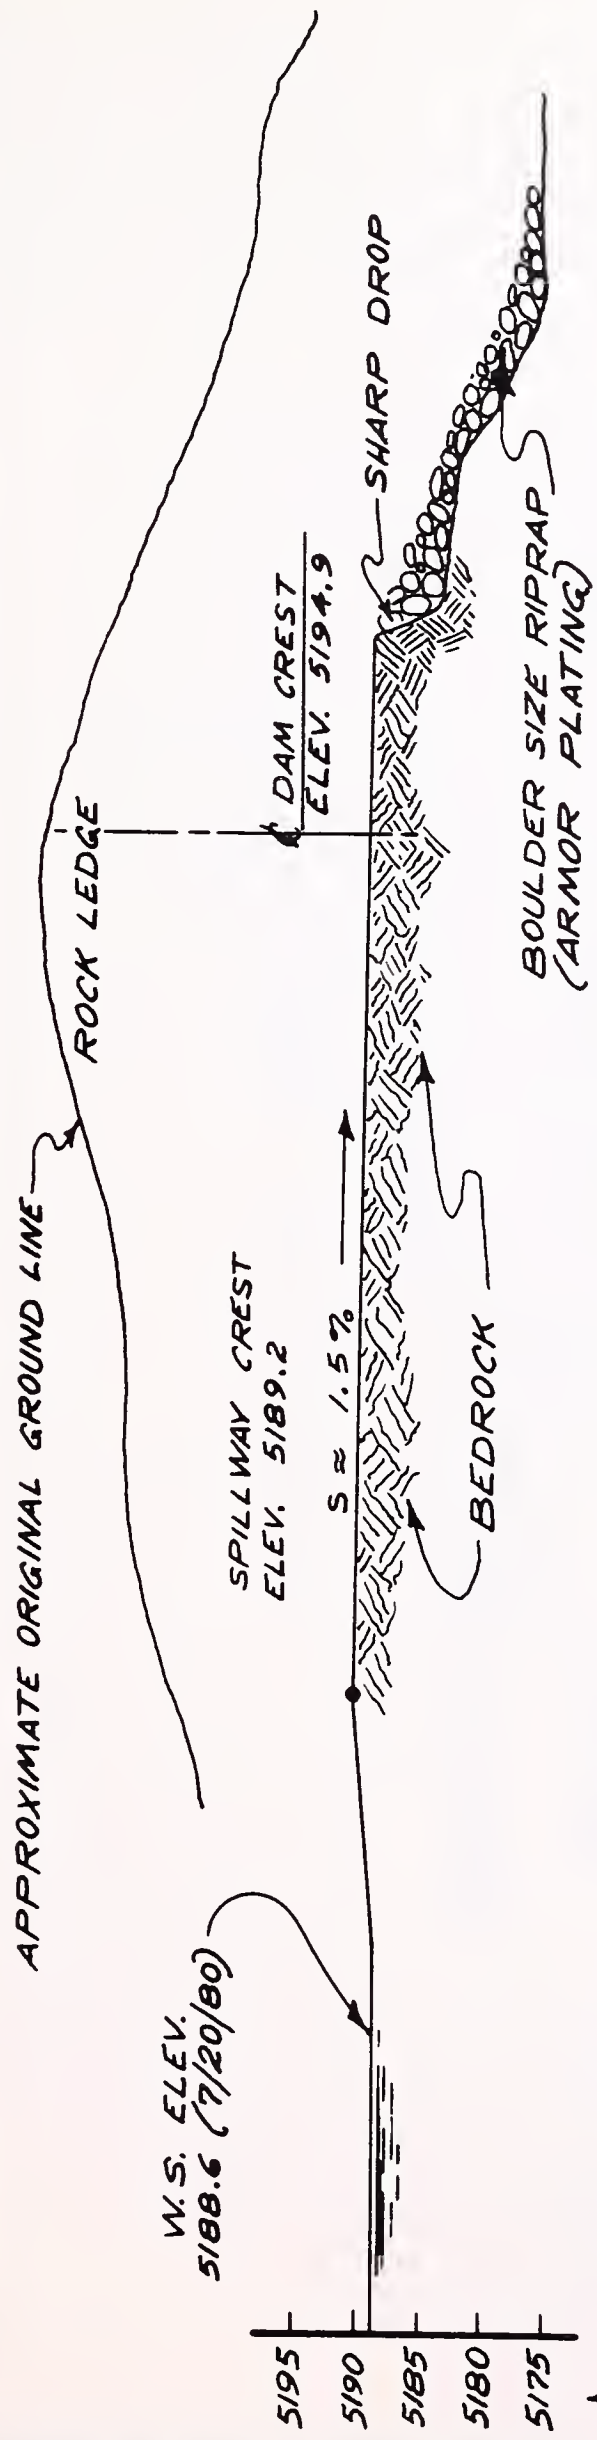
PLATE 4 **HACKER DAM** **EMERGENCY** **SPILLWAY**

The uncontrolled earth and rock lined emergency spillway is 20 feet wide, 85 feet long and has a crest elevation 5189.2 feet MSL. Side slopes are about 1V to 2H. There is a 30-foot long approach section with a 2% adverse slope followed by an 85-foot long section with a 1.5% favorable slope. (Plate 4) Water flows drop 3 to 4 feet over a ledge at the end of the 85-foot long section to enter a steep exit channel which terminates near the downstream toe of the dam at the left abutment contact. The steep exit channel has seriously eroded in the past and presently has the bottom covered with large boulders for protection. (Photo 4) The boulder size riprap is subject to possible scour and removal during high spillway discharges. The spillway shows signs of operating almost every year, and therefore has a high potential for erosion damage. The maximum discharge capacity of the spillway with the reservoir at dam crest was estimated to be 940 c.f.s. The discharge rating for the emergency spillway was developed by assuming critical depth computing backwater effects (head losses) in the approach channel.

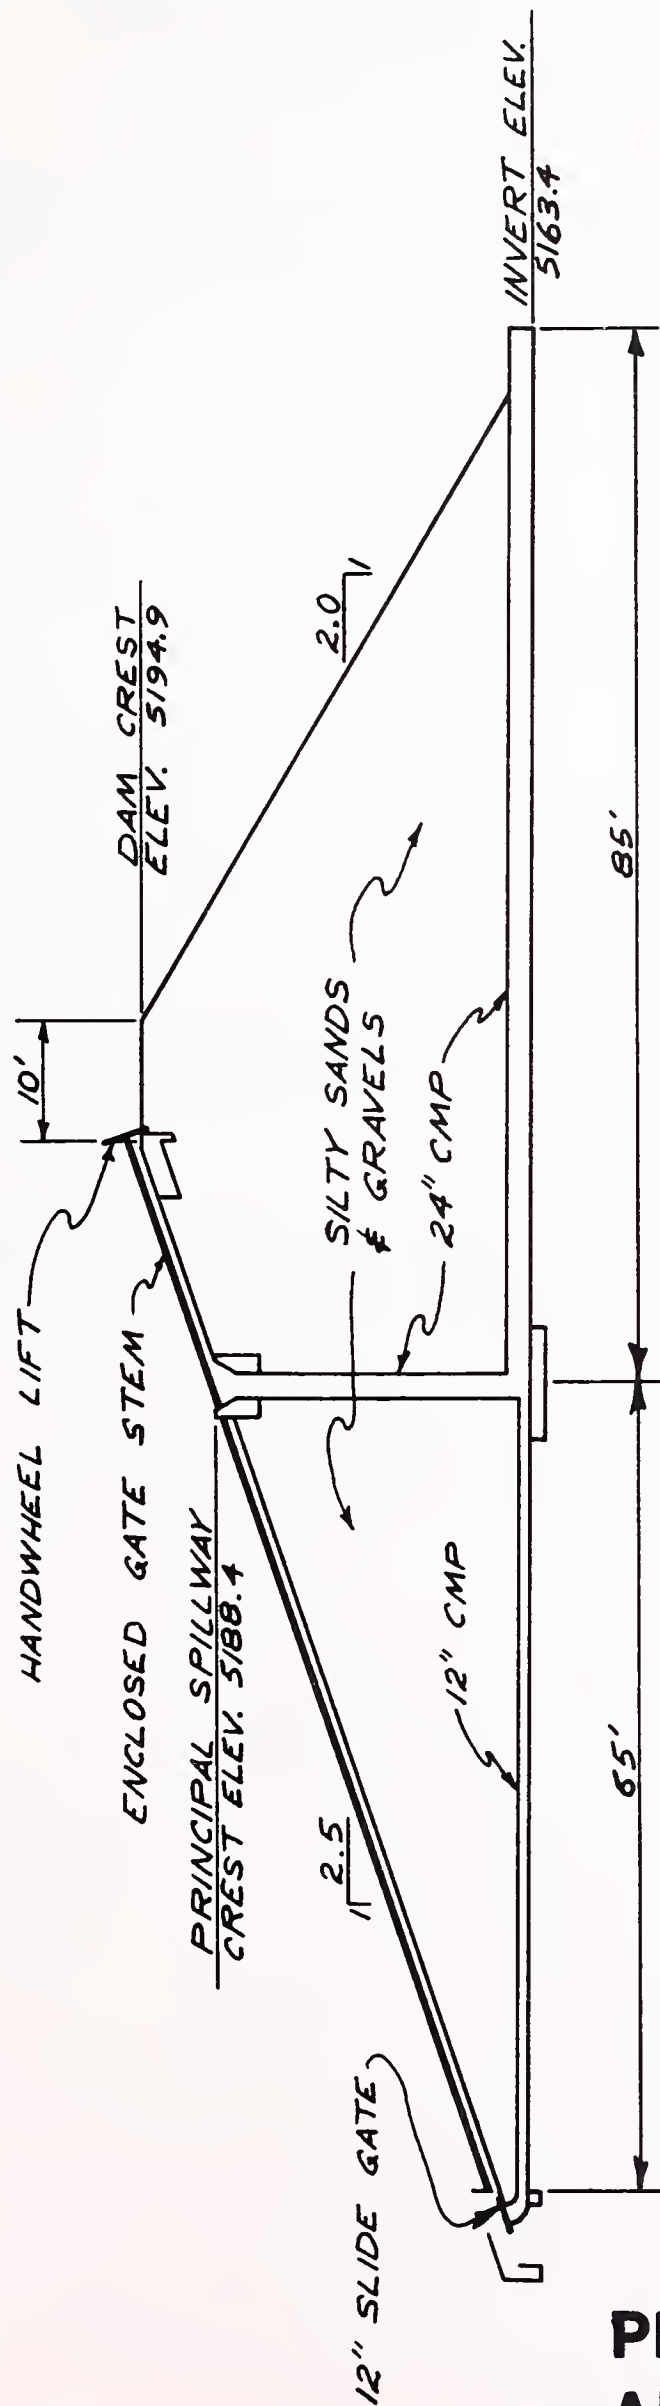
PLATE 5
HACKER DAM
PRINCIPAL SPILLWAY
AND OUTLET WORKS

The outlet works and principal spillway are combined into a single unit located near the center of the dam. (Plate 5) The principal spillway is uncontrolled, and has a 37" X 37" inside-diameter monolithic concrete

inlet resting on top of a 24-inch-diameter corrugated metal pipe riser. The crest elevation of the principal spillway is at assumed elevation 5188.4 feet MSL. The riser connects to a 24-inch-diameter CMP outlet which extends through the embankment, and serves as a common outlet for the controlled low-level outlet pipe and the principal spillway. The low level outlet is a 12-inch-diameter corrugated metal pipe which extends from reservoir inlet to the bottom of the principal spillway riser. A 12-inch-diameter sluice gate controls the inlet, with a hand wheel lift and lift base located near the upstream shoulder of the dam crest. The gate operating rod (gate stem) is located on the upstream face of the embankment dam.

The field fabricated trash screen on the principal spillway is inadequate to insure operability. The gate on the low-level outlet was reported as inoperable at the time of investigation. Due to the small size of the conduit and a small flow over the principal spillway crest the pipe was not inspected. There is no means to control principal spillway discharge in the event of an emergency.

2. Inspect the entire length of principal spillway and low-level outlet conduit, and repair as required. Provide means for closure of the principal spillway in the event of an emergency.

3. Periodically test the operation of the outlet gate to prevent "freezing" on the slide contact.
4. Replace the trash rack on the principal spillway riser with a durable and functional structure.
